COMANDO DA AERONÁUTICA
CENTRO DE INVESTIGAÇÃO E PREVENÇÃO DE
ACIDENTES AERONÁUTICOS

FINAL REPORT
A-582/CENIPA/2014

OCCURRENCE:	ACCIDENT
AIRCRAFT:	PR-TKB
MODEL:	ATR 42-500
DATE:	06 JAN 2012

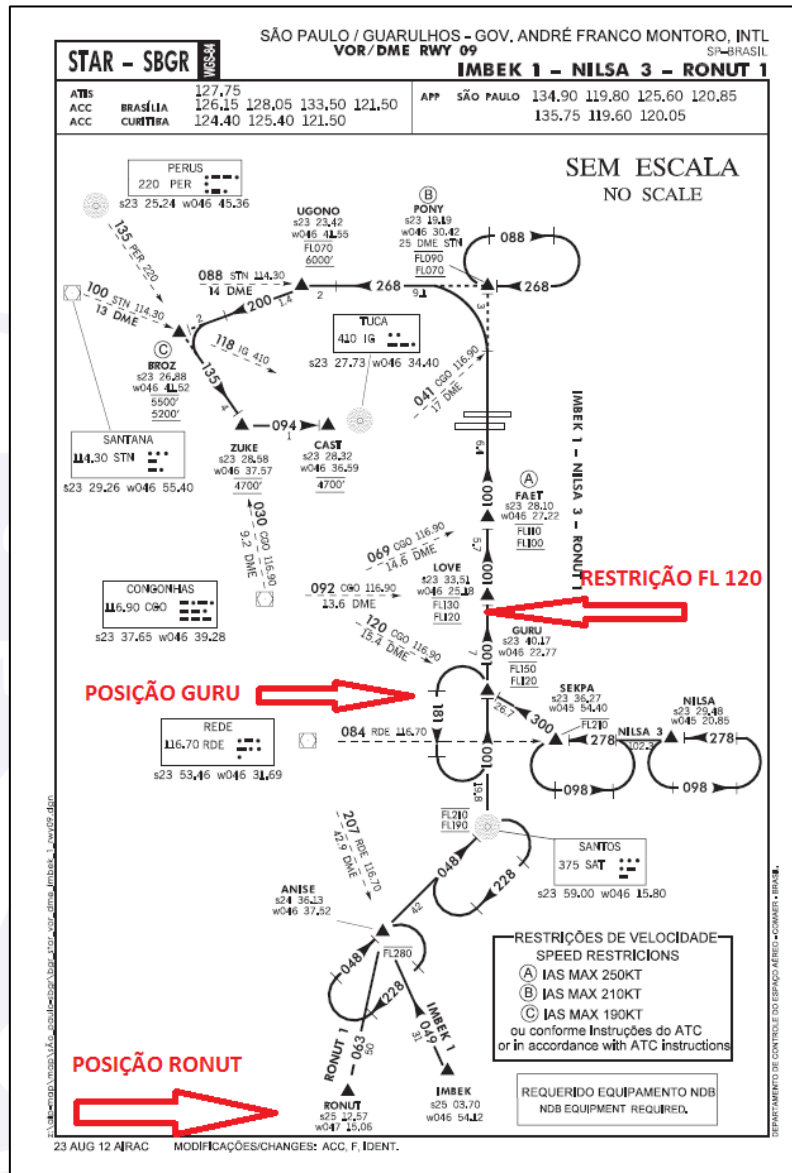
Figure 1 – RONUT 1 STAR

The recordings of the communications between ACC-CW and Flight TIB5333 show that ACC-CW informed that RONUT 1 (Figure 1) was the STAR prescribed for the approach to SBGR.

Upon intercepting the RONUT 1 STAR at GURU position, Flight TIB5333 failed to comply with the instruction given by APP-SP concerning the descent to FL120. It also failed to comply with the FL120 restriction in the segment between GURU and LOVE positions contained in the RONUT 1 STAR.
